Manufacturing Company

40 North 2nd Street Stroudsburg, PA 18360 USA 570-421-6221 Indicator movement of the balancing arbor assembly is dampened by the dashpot action of the damping oil contained within the assembly between its outer shaft and the central suspension rod.

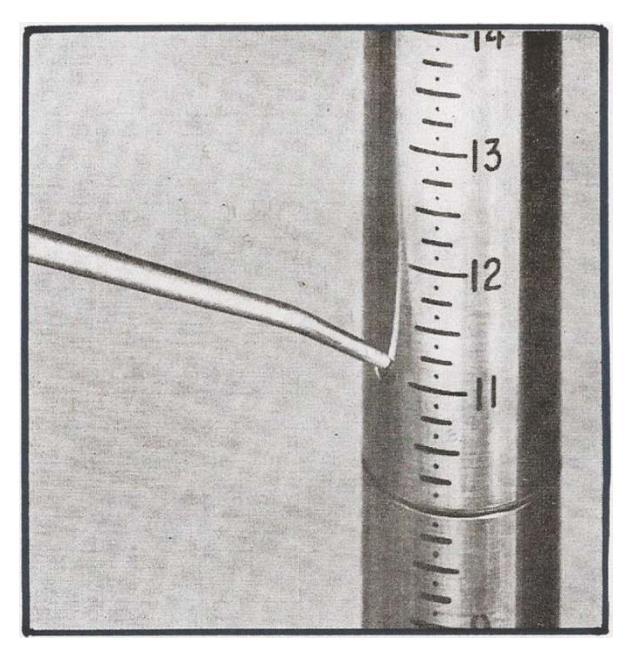
The four oil fill/drain openings in the arbor shaft (located at the 1 $\frac{1}{2}$, 11, 19, and 27 inch scale positions) are sealed with button head hex socket screws. Damping oil may be added or drained through these openings. It is recommended that the opening at the 11 inch scale position be used to add oil using a pump type oil can, with the arbor in a vertical position. Use SAE 40 viscosity mineral type engine oil and fill to the level of the opening located at the 19 inch scale position.

Should excessive oscillation of balance indications develop due to inadvertent loss of arbor damping oil, proceed as follows:

Should complete change of damping oil be desired (usually due to "stickiness" developing from oxidation of the oil) remove sealing screws, lay the arbor on its side with two of the oil holes downward, and allow oil to fully drain. Flush the arbor assembly with a cleaning solvent such as mineral spirits (varsol) to remove any sticky deposits. Reinstall sealing screws and the 1 $\frac{1}{2}$ and 27 inch scale positions and refill with fresh damping oil as previously directed.
